# OPERATING EXPERIENCE AND RELIABILITY IMPROVEMENTS ON THE 5 KW CW KLYSTRON AT JEFFERSON LAB

R. Nelson, S. Holben, Thomas Jefferson National Accelerator Facility, 12000 Jefferson Avenue, Newport News VA USA 23606

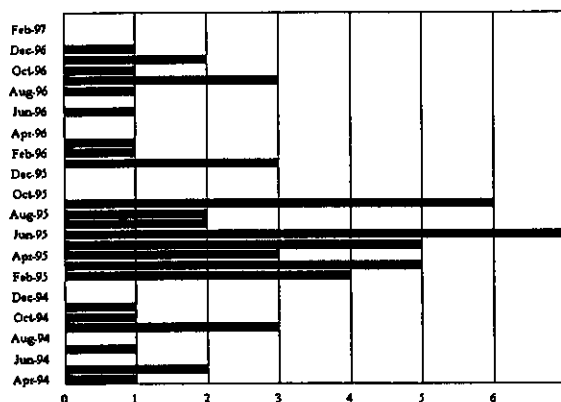
The spec requested tubes with at least 20-25k hours life. Overall, even with a high number of early failures, the MTBF was around 22k hours by 1994. Currently, the hours/failures ratio shows about 90K hours of filament operation and 67k hours of HV operation average. None of the failures so far has been from normal wear out, that is, cathode depletion. Instead, catastrophic failures have ranged from open heaters to external arcing.

Figure 1 - Klystron Failures by Month

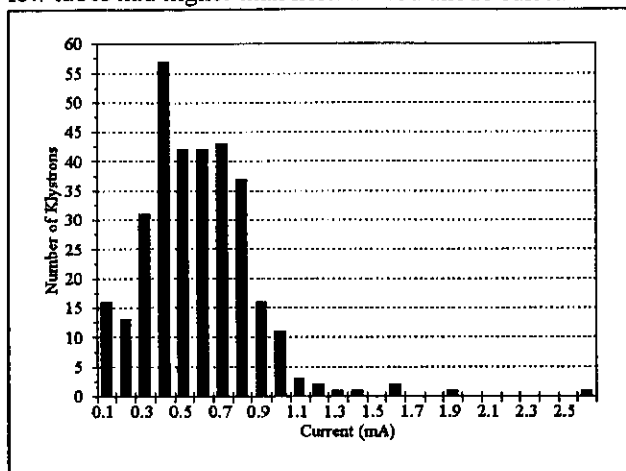
Figure 3 - Mod Anode Current Distribution

Original specs required mod anode intercept to be < 1% of beam current, which equated to <13 mA. Assuming that most of the current intercepted by the modulating anode was dissipated by the metal and ceramic through the potting material, we simulated additional heat on our thermocouple equipped tube by increasing heater power. The temperature reached 250 °C with another 30 watts input. So while 12 mA of intercept would fall within the specs, it would also generate 139 watts of heat. The gun would fracture well before that point. In fact, at least three tubes have suffered that fate, so it is convincing that excessive mod anode current was probably a major contributor to potting failures.

We had lowered the cathode voltage but kept the heater setting at the nameplate value. Running a curve of cathode emission vs. filament voltage, we found that most tubes would operate satisfactorily with about 75% of the rated voltage. Running cathodes hot had resulted in excessive barium boil off and internal contamination. Since resetting individual filament voltages based on emission curves, the failure rate has dropped noticeably.

Because mod anode current was found to be a critical measure of the tube's health and an indicator of impending failure, permanent monitoring has been installed on all klystron positions. This parameter is now remotely monitored, and can be logged or trip the power supply if a preset threshold is exceeded.
